**DEPARTMENT OF TRANSPORTATION****DIVISION OF ENGINEERING SERVICES**

Contract #: 04-0120F4Cty: SF/ALA Rte: 80 PM: 13.2/13.9File #: 69.28**WELDING INSPECTION REPORT****Resident Engineer:**Siegenthaler, Peter**Address:** 333 Burma Road**City:** Oakland, CA 94607**Report No:** WIR-021660**Date Inspected:** 09-Mar-2011**Project Name:** SAS Superstructure**OSM Arrival Time:** 700**Prime Contractor:** American Bridge/Fluor Enterprises, a JV**OSM Departure Time:** 1900**Contractor:** Zhenhua Port Machinery Company, Ltd (ZPMC), Changxing Island **Location:** Shanghai, China**CWI Name:** An Qing Xiang.**CWI Present:** Yes No**Inspected CWI report:** Yes No N/A**Rod Oven in Use:** Yes No N/A**Electrode to specification:** Yes No N/A**Weld Procedures Followed:** Yes No N/A**Qualified Welders:** Yes No N/A**Verified Joint Fit-up:** Yes No N/A**Approved Drawings:** Yes No N/A**Approved WPS:** Yes No N/A**Delayed / Cancelled:** Yes No N/A**Bridge No:** 34-0006**Component:** OBG components.**Summary of Items Observed:**

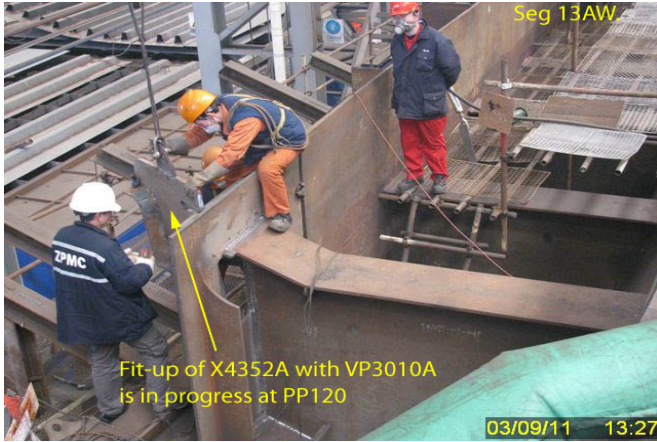
This QA Inspector observed ZPMC personnel performing fit-up of X4352A with Vertical Plate (VP) 3010A at

PP120. ZPMC QC was identified as Liu Feng. See attached photo for further information.
